POWER EQUIPMENT

FLA

Field Lightning Arrestor

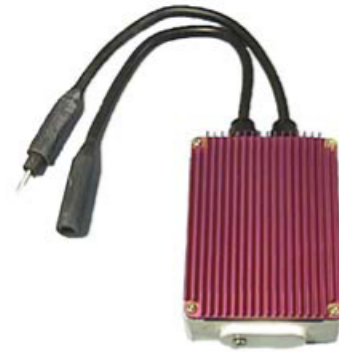
- For use on airfield series circuits to further reduce the risk of lightning damage on the series circuit
- Can be inserted at various points in the 5 kV airfield primary series circuit to provide additional lightning protection.
- Can be used on any airfield circuit (6.6 A from 4 kW to 30 kW and 20 A from 15 kW to 70 kW)
- Rated for 25,000 A peak (8/20 microsecond discharge)
- Assembly rated NEMA 6P
- Insulation resistance is 10 GΩ (minimum)
- Includes a UL 467 rated ground lug, which accepts an AWG 4 to AWG 14 earth ground wire
- Operating temperature: -55 °C to +55 °C (-67 °F to +131 °F)

It is recommended that the field lightning arrestor be installed a maximum of about every 2,000 feet around the series circuit, starting at the first base can closest to the vault on each leg of the series circuit. Simply disconnect (unplug) the L-823 connectors at the designated point and plug in the field lightning arrestor. Connect a known good earth ground (25 Ω or less) to the earth ground lug of the field lightning arrestor using at least an AWG 6 wire.

The field lightning arrestor can be installed in a base can (preferred) or direct earth buried. Heat shrink each L-823 connector interface using an airport approved method. The field lightning arrestor body is waterproof (rated NEMA 6P) and is fully resistant to deicing fluids.

There are no internal repairable parts since the field lightning arrestor is completely sealed. If the field lightning arrestor fails, replace it with a new one. Note that the heat sink on a field lightning arrestor is colored red in order to differentiate it from the ADB Safegate BRITE Remote. An ADB Safegate BRITE Remote has a silver colored heat sink.
